# THE £50 NOSE JOB

**Royce Creasey offers a solution to the problem posed by the damage a slack alternator rotor causes to the crankshaft.**

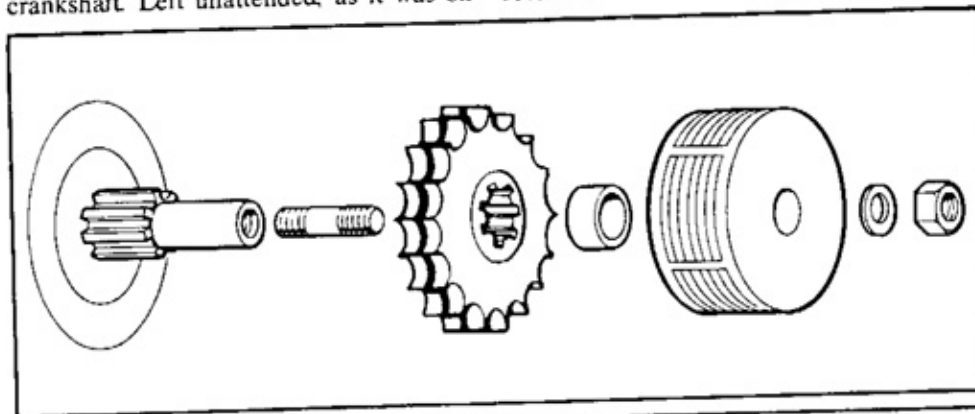
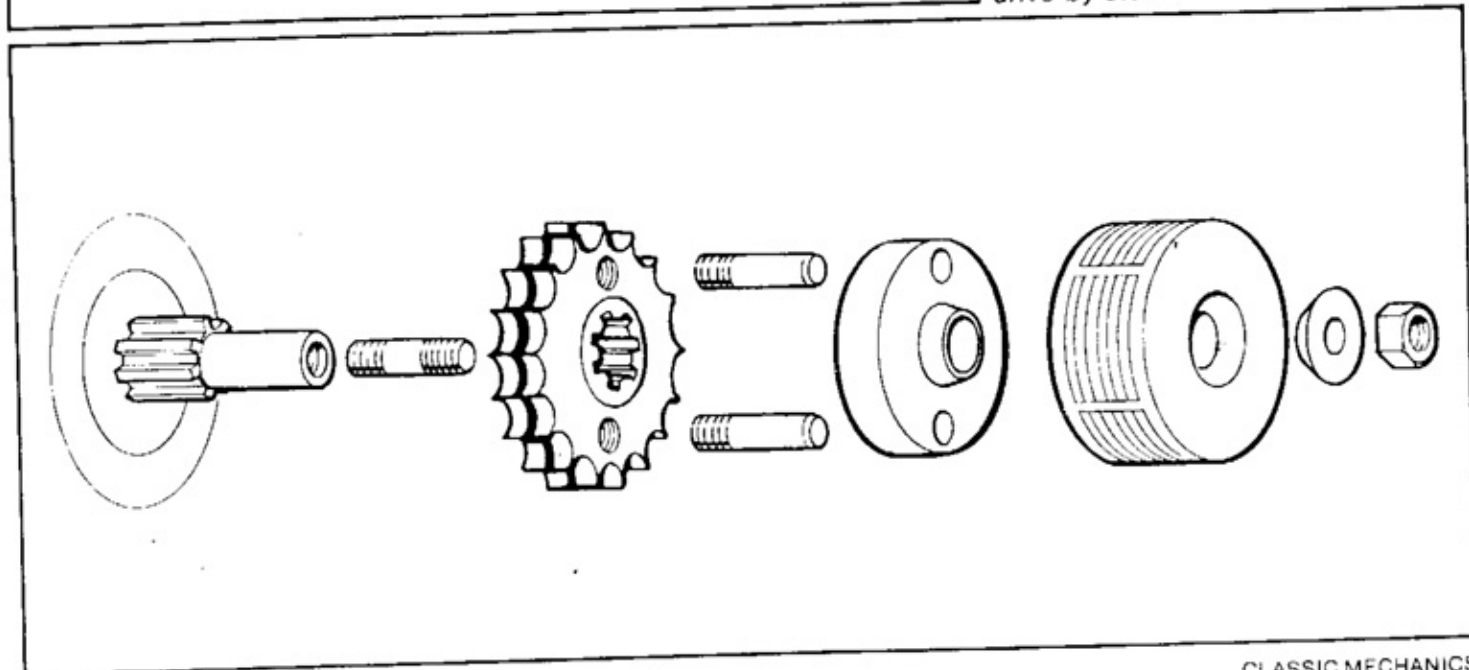
It is not uncommon for the owner of a *The standard arrangement is shown at top. Rotor is held in place by clamping effect of nut and spacer and positioned by a woodruff key (not shown). Electrical drag, crankshaft pulses and acceleration and weight around the periphery make this a less than ideal set-up. Creasey's modification ensures positive location by tapered spacers and peripheral drive by studs.*

Close study of this little set of components rapidly reveals that it is more wonderful that any stay in one piece than surprising that some fall apart. The rotor is centralised by sliding along a shaft. It therefore has a running clearance which uses up a significant proportion of the .012in air gap one is somehow expected to achieve between rotor and stator. It is retained by the simple

expedient of clamping it between a nut and a spacer. Location is actually provided by the friction in shear at these faces and the woodruff key usually added can only position the alternator, which may be useful for ignition timing. The clearance required around the key means that if the nut slackens and the locating friction drops, the key will be cut in two. When that happens the rotor is stopped, or at least slowed by the alternator's electrical drag and rapid wear, assisted by bits of woodruff key, takes place on the crank and in the rotor bore. Every now and then this 'bearing' seizes and the somewhat off-centre result chips away at the stator for a change. You may notice a drop in the charging rate around this time.
