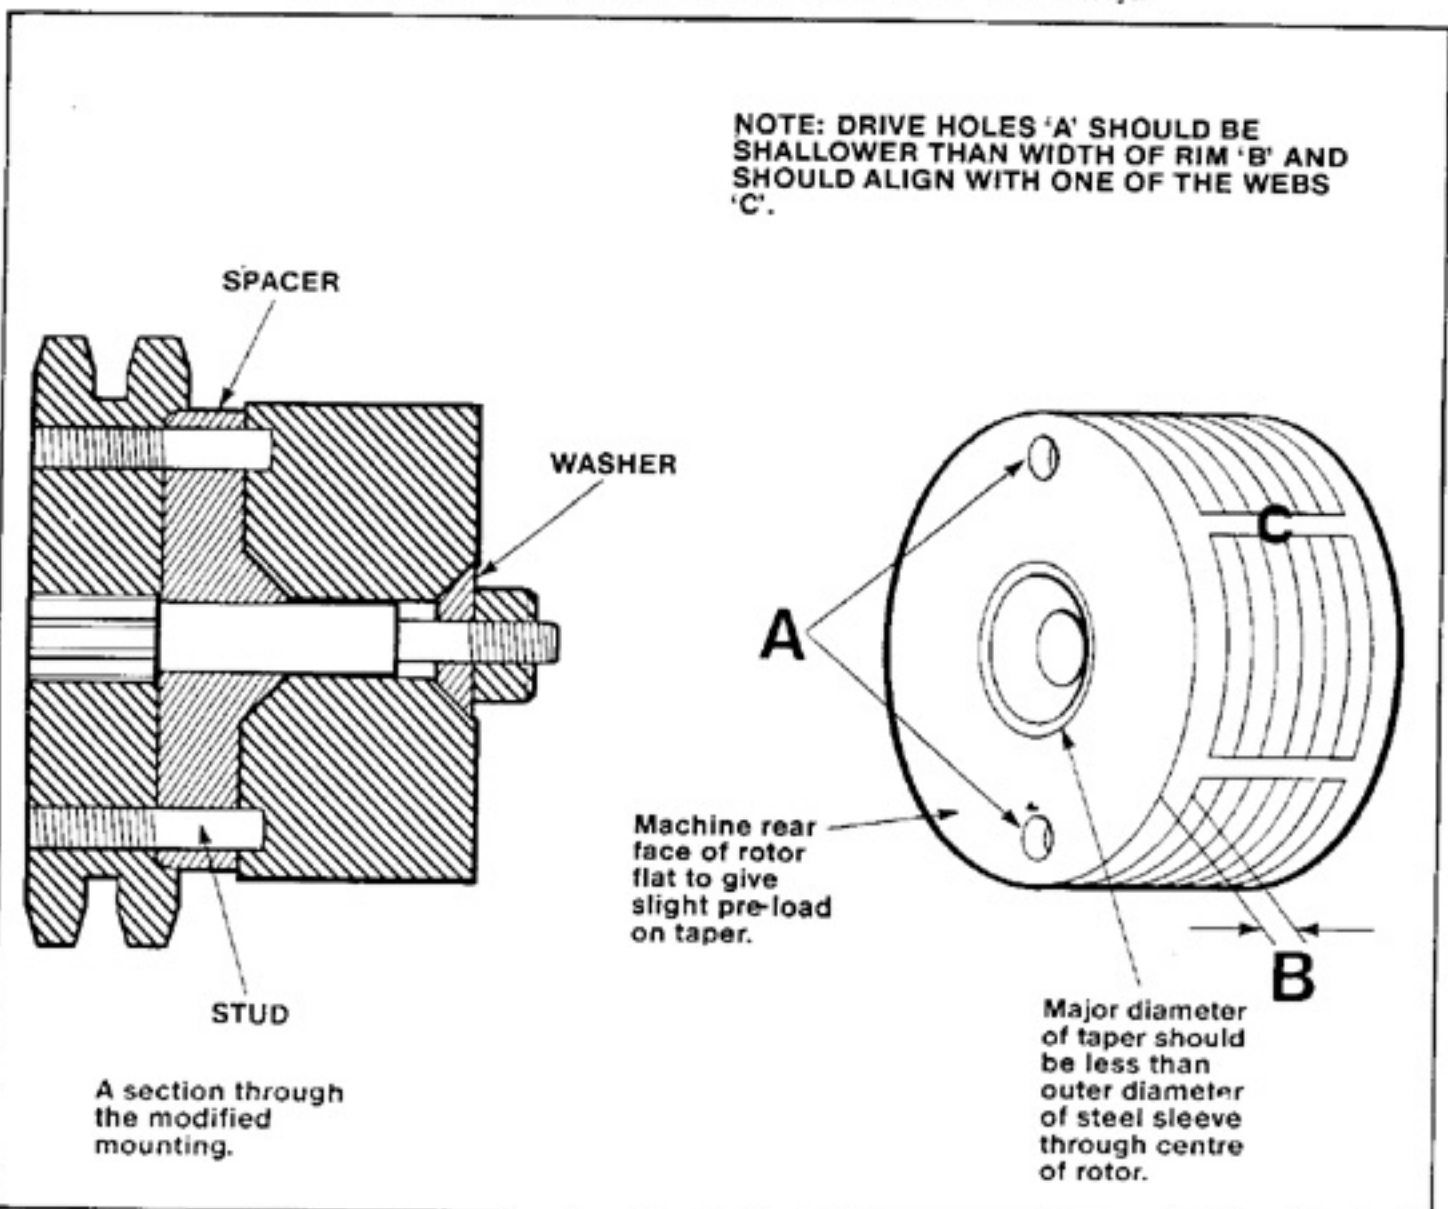
When all the wreckage has been scraped out of the chaincase it will be noted that between the rotor and the engine sprocket there is a spacer. Although the outer face of this spacer may be well ruined, beneath it the crankcase nose is undamaged. This provides centralisation. A new spacer is made which has a flat face as thick as the original, but a diameter as large as the new rotor you have just bought. Its rear face will need to be shaped to fit into the sprocket. At the centre of this disc is a male taper, quite small, with a major diameter of about two-thirds that of the steel sleeve through the new rotor. The remnants of the washer that fitted under the rotor retaining nut are

discarded and a new washer made, which includes an identical male taper. As you would expect, your new rotor then has a female taper machined into either end of its bore. It's important that the tapered washer is well over-size on the stud sticking out of the crank.

This takes care of centralisation and retention as the rotor centralises on the taper at the rear, and is trued by the flat face of the new spacer. The tapered washer simply holds it on and will not pull the rotor out of true even if the stud is bent, providing that over-size is there.

All that remains is to drive the rotor and this is best done as near as possible to its periphery, in order to reduce drive torque and minimise the effect of all those pulses. Fortunately the Triumph engine sprocket has two threaded holes for extraction (head studs fit) and these two holes are extended through the new spacer and into the rotor, taking care that they line up with the webs between the magnets. As these holes only drive they can be quite shallow and should not break through the alloy sides of the rotor. A couple of head studs can then be cut down to suit, just clearing the bottom of the holes in the rotor, and you have an assembly. There are minor details such as

the correct taper - I used 45 degrees but any proper engineer will know the official angle, and of course if you own a machine without extractor holes in the sprocket you'll have to make them, but this does seem to be a final solution. It's even easier than the original to fit and dismantle, especially on a really chewed up crank with lots of clearance.
